Tech Brief - Coil Failure Analysis

Tech Brief: Coils Series

Coil Failure Analysis

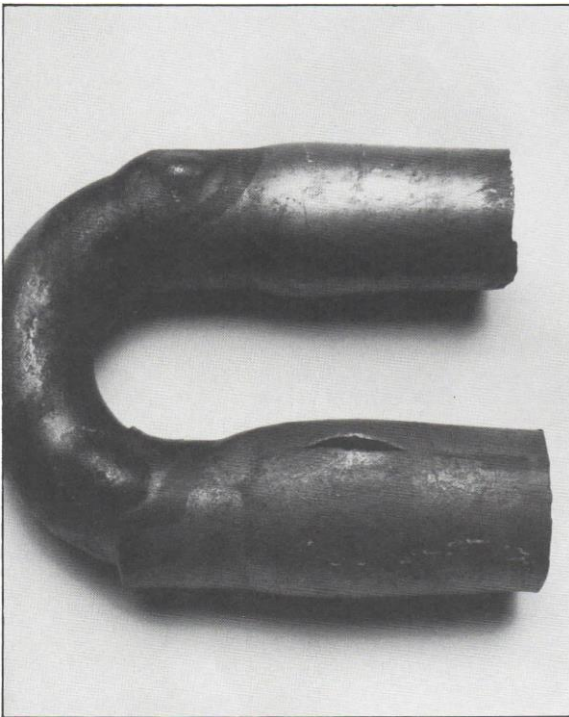
PHOTO 1:

Although freezing can burst any tube material, softer metals like aluminum, copper alloys ...or this copper tube shown here, often bulge around the split.

Leaks in the coil face that are caused by freezing are easy to detect. The leaks show up as longitudinal splits ranging from 1'2" to 2" in length. Although all tube materials can freeze and burst, softer materials such as copper, copper alloys and aluminum, often bulge around the split. Freezing failures are not necessarily located in the lowest tubes in the coil. Often, they appear to be located randomly throughout the face of the coil.

In return bends, freeze-ups usually occur in water coils and show up as longitudinal splits in the end of the return bend. Occasionally, the tubes directly adjacent with the return bend bulge and/or fail as well. See photo 1.

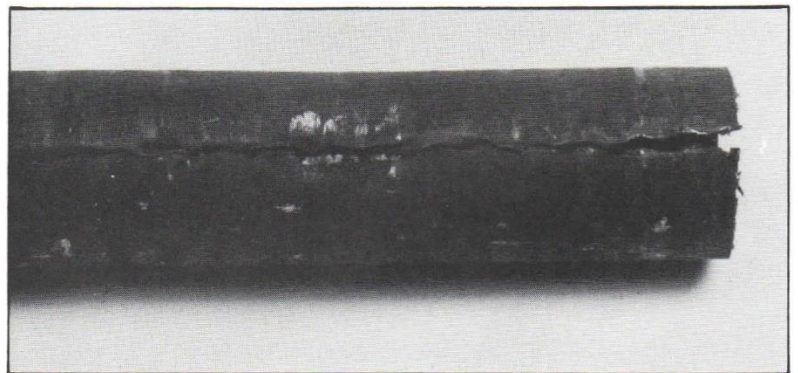
PHOT03:

Though it may look like a freeze failure, the tube shown here failed due to "uniform corrosion".

Uniform corrosion also causes corrosion problems in some applications. This form of corrosion causes uniform thinning in the tube wall. Eventually, the tube wall thins to the extent that normal operating pressures cause the tube to fracture. The fractures are normally longitudinal and may look much like a freeze failure except that the edges are jagged and thin. See photo 3.

In the case of steam coils, uniform corrosion is usually caused by concentrations of carbon dioxide that become carbonic acid in the condensate. The condensate flows down the bottom half of the tube which causes the bottom half of the tube to thin over time.
